## Figure 2-11 Mile 97 Jaralosa Arroyo

**Targeted River Restoration Alternative**

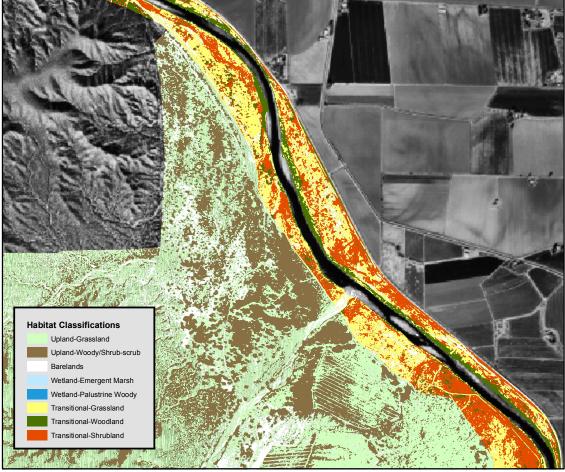
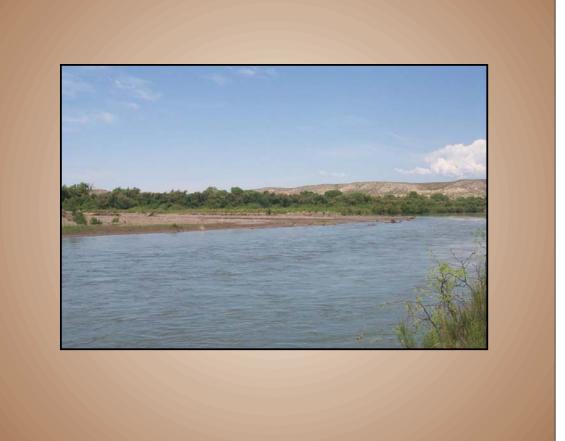
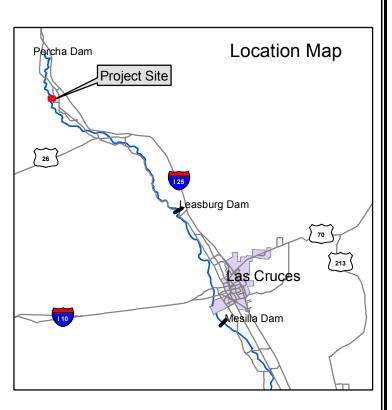
Jaralosa Arroyo enters the west side of the river near mile 96.5 through a channel, which diverted flow from its original route. The channel conveys the combined flow of Jaralosa Arroyo and Berrenda Creek both of which have dams. Despite the dams, the arroyo deposits sediment that creates islands in the river. Part of the ROW is leased for cultivation (approximately 60 ac). A former meander is on the west side of the river. Although the meander is outside the hydrologic floodplain, it presents a restoration opportunity (through excavation) due to ROW width.

Point Project Measures	ID	#	Area
			(ac)
Open former meander	97C	1	28.0
Modify dredging at arroyos by	97D	1	0.44
creating embayments
